MARKING SCHEME

SUMMER 2018

**CONSTRUCTING THE BUILT ENVIRONMENT
9811/01**

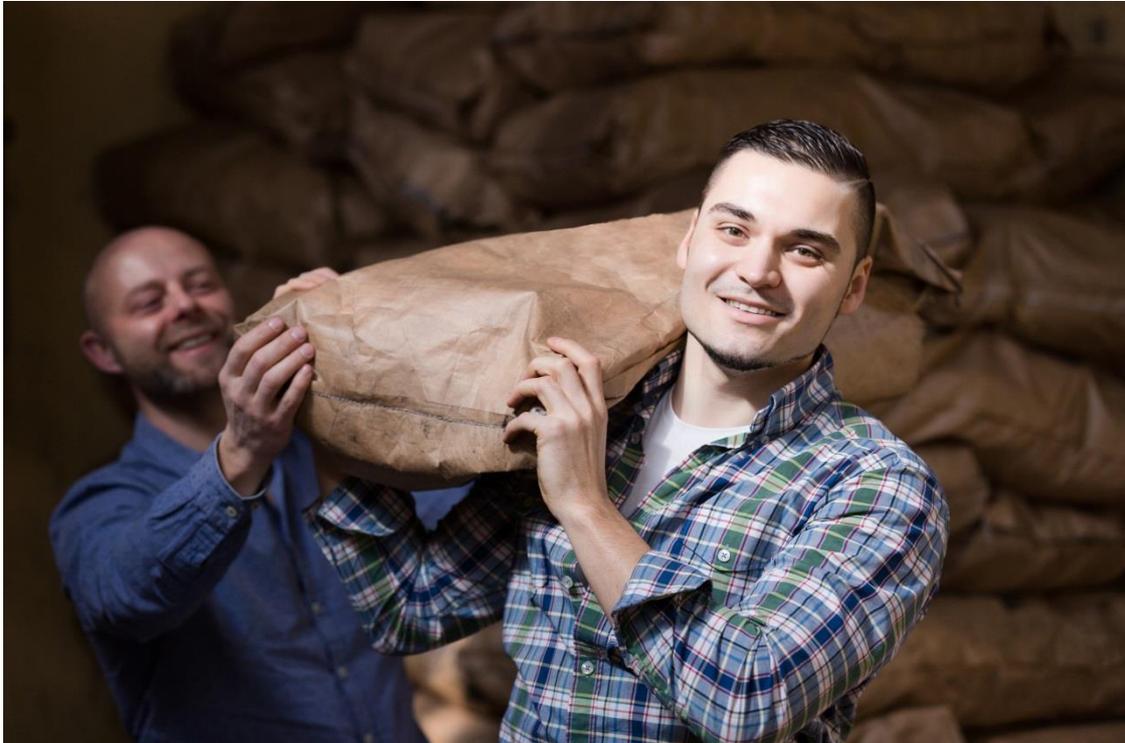
1. The worker in the photograph is carrying a 50kg bag of cement.
 - (a) What is the maximum load a construction worker is usually allowed to carry [1]
25kg
 - (b) What could the worker do, in order to reduce the risk of injury? [1]
Use a wheelbarrow or sack truck (1)
Share the load with another worker (1)
Specified PPE (correct goggles - boots)
 - (c) Name one piece of legislation which covers this situation? [1]
Manual Handling Regulations (1)
HASAWA (1)
The Management of Health and Safety at work regulations (1)

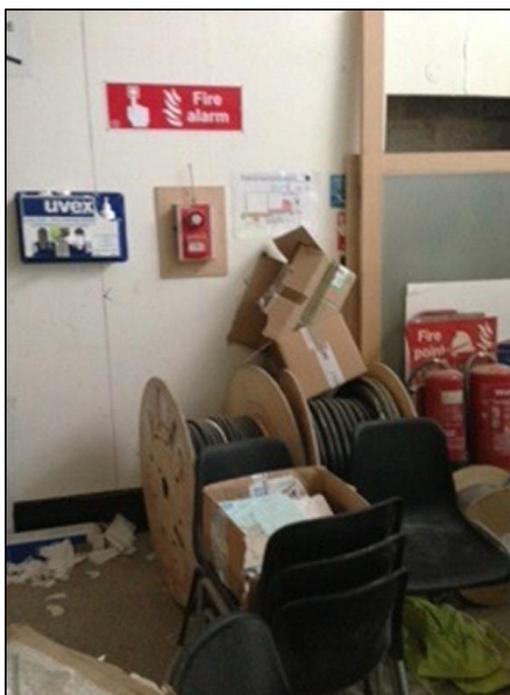
2. The photograph above is taken at our site in Tiverton. This office is fully operational during working hours. The Health and Safety Officer is very concerned about left over materials and office furniture causing problems and has informed staff to rectify the situation immediately.

1. Cannot reach the fire alarm - the inability to set the alarm off and thereby alert staff could be highly dangerous and even lead to loss of life (2)

2. Cannot reach the fire extinguishers - the inability to access and thereby use the extinguishers could create additional dangers through the spread of the fire (2)

3. There is potential trip hazard - this could cause injury and hinder their escape (2)

4. Combustible material is a potential hazard - this could contribute to the spread of the fire. (2)

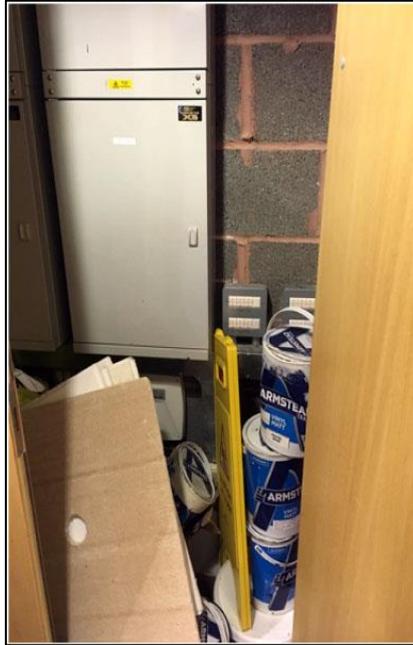
3. JJI have an issue with a partly handed over section in phase one of a recently refurbished office block. The site foreman has noticed that the painters have been storing their paint and tools in the electrical store cupboard shown in the photograph above.

Unable to gain proper access in an emergency to shut down electrical supply (1)

Heat source next to flammable paint (1)

Fumes from stored paint (1)

Trip hazard (1)

Materials falling (1)

Liquid and electricity (1)

Lock the cupboard door (1)

Warning signage (1)

Inform staff not to use for storage as part of induction (1)

Daily inspections (1)

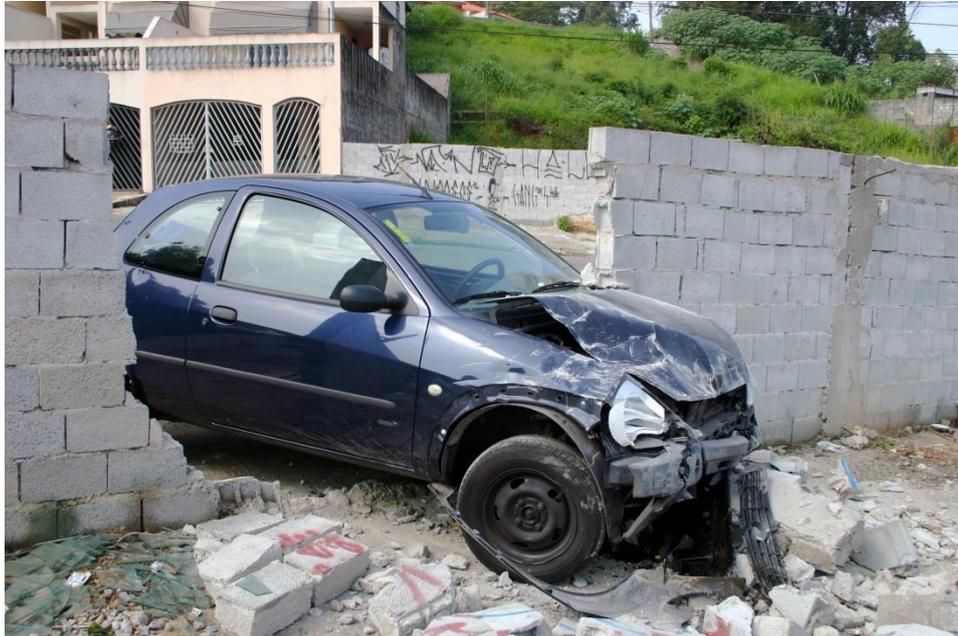
6. Yesterday, an accident happened at one of our north division sites. Fortunately it happened outside normal site hours and no one was injured. The car shown in the photograph has damaged the site boundary wall and has now been removed by the police. This area of the site is where the site compound is located. The compound is where tools, materials and equipment are stored.

Potential theft of tools, materials and equipment.

Potential vandalism of the site.

Potential danger to children entering the site to play.

On-site security.

CCTV cameras

Motion sensor alarms

Temporary fencing

Securing wall (make safe)

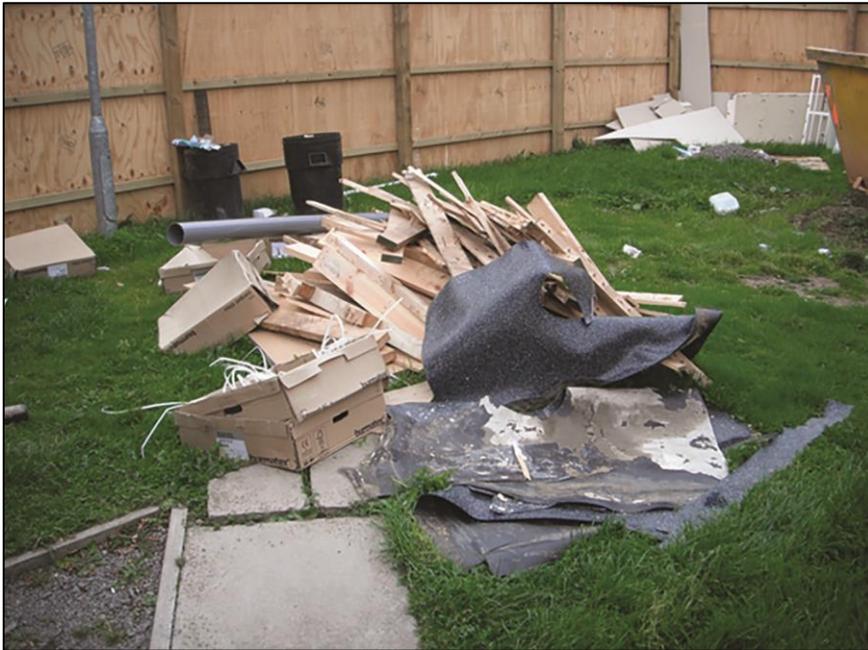
Image 1

This is a photograph of the garden of one of our virtually completed houses. The buyers are looking to move into the property immediately.

Hazard 1 (Photo 1)
Inappropriately stored material.
Risks (Image 1)
The materials are poorly stored and could easily cause someone to trip – the site should not be dangerous like this. Workers are used to clear areas and such a mess is not expected. Debris could also be blown in the wind as items such as boards are prone to this. Some of the sheet material could be slippery especially when raining.
Control Measures (Image 1)
Rubbish should be removed from site when possible and disposed of correctly. A properly used skip (which is on site) would help greatly. Materials which are to be used should be held safely and securely in appropriate storage.

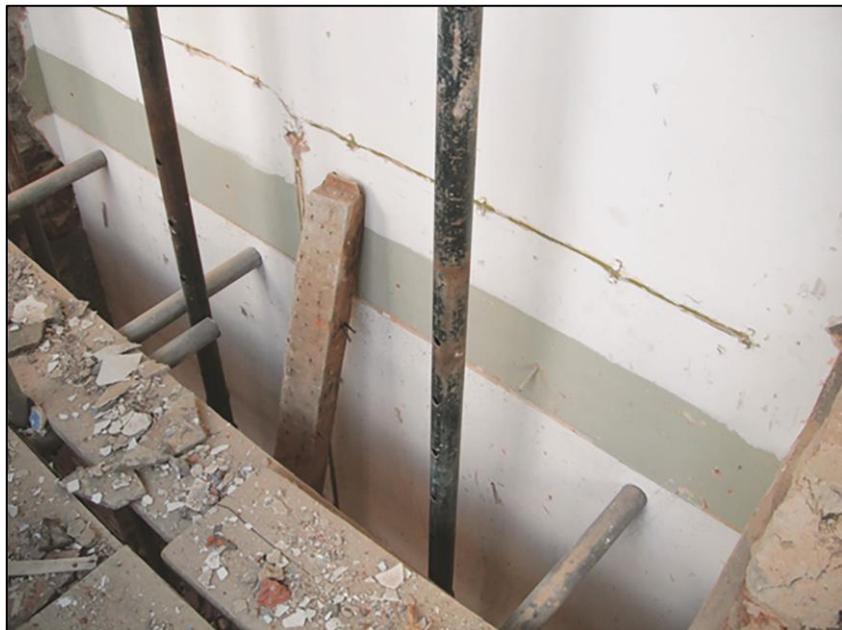
Image 2

This is a photograph of the interior of our partially built houses.

Hazard 2 (Image 2)
Missing scaffold board
Risks
Falls and possible trips. Danger of falling tools and materials. (3)
Control Measures
Complete scaffold board to perimeter of wall. Employ competent scaffolders. (3)

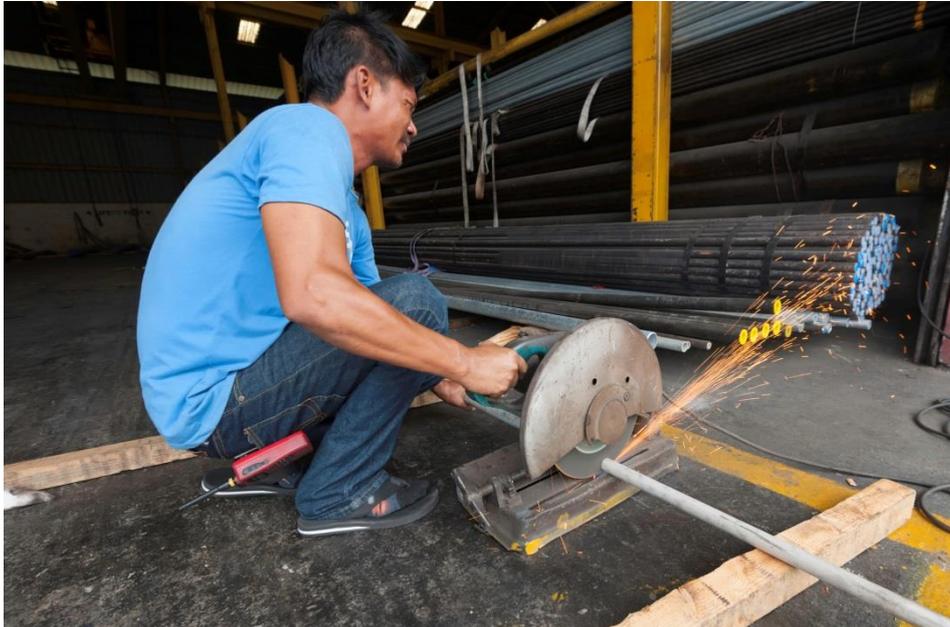
Image 3

This is a photograph of one of our employees in the workshop cutting steel reinforcements for the floor slabs.

Hazard 3 (Image 3)
The employee is cutting the steel reinforcements with no PPE being worn
Risks
Possible damage to: Eyes as a result of sparks Hands and face as a result of sparks Feet as a result if manual handling Ears as a result of noise Respiratory system (3) Debris falling in people eyes
Control Measures
Warning signs, training and checks to ensure: Goggles are worn Boots are worn Gloves and overalls are worn Ear defenders are worn Face masks are worn (3)

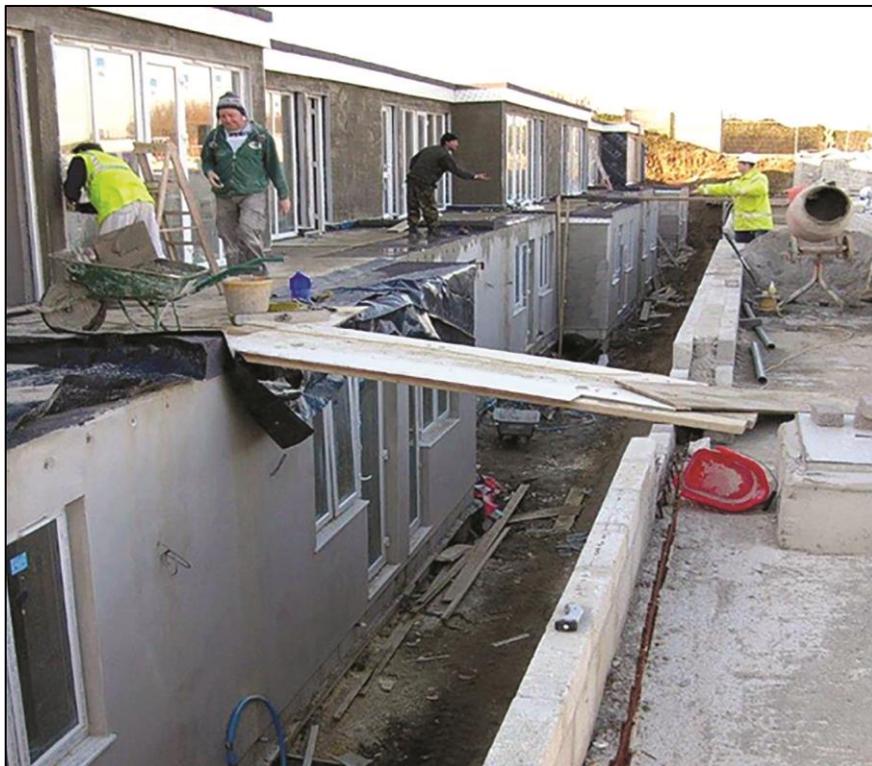
Image 4

This is a photograph of one of our construction sites in the east division.

Hazard identified (1)
<p>No safety signage.</p> <p>No clear walkways and significant levels of debris.</p> <p>Temporary ramp, at height with no safety rails.</p>
Risks (3)
<p>Many fold - e.g. lack of hard hat signs - some employees wearing others not. (Whilst there may potentially be signs at the site entrance there is a distinct lack of signage in the image - out of line with typical site practice.</p> <p>Trip and collision risk of injury - especially where machinery or loads may be involved. The existence of discarded wood, scaffolding poles and other items are a major health risk.</p> <p>Falls from the ramp and the dropping of materials, especially heavy loads such as those in wheelbarrows. Employees under the ramp may be danger of falling items. Ramp is not secured and uses various pieces of wood providing an uneven surface. The lack if safety rails increases the potential risks noted.</p>

Control Measures (4)
<p>Provide correct signage - these may cover all sign types.</p> <p>Site should be cleared and materials discarded or stored properly.</p> <p>Barriers should be erected where employees are working and need to be separated from other employees.</p> <p>Properly built ramp with flat surface and barriers. Signage in place and a no-go zone or appropriately system in place to protect workers under the ramp.</p>
